HITLER'S TANKS

GERMAN PANZERS OF WORLD WAR II

EDITED BY
CHRIS McNAB

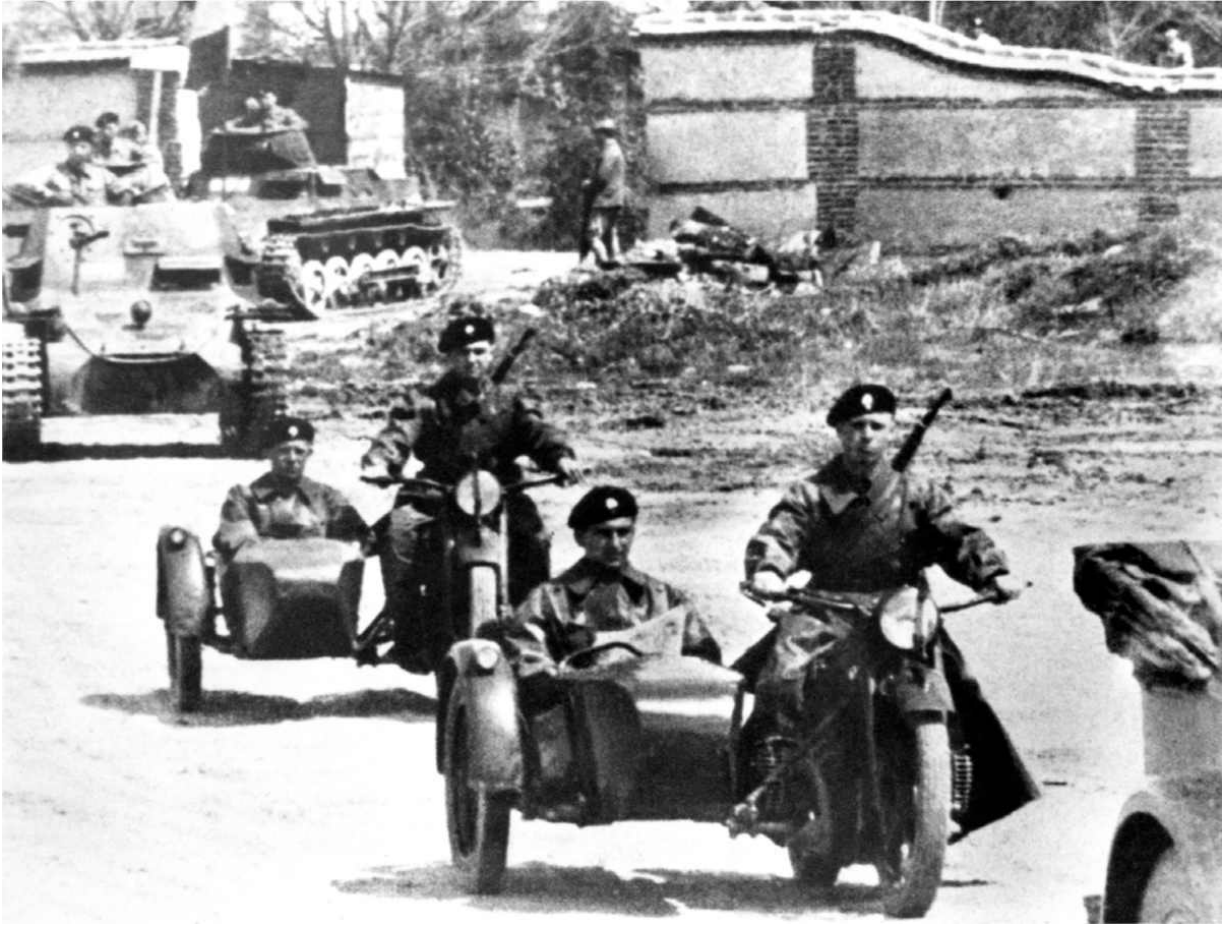
A German PzKpfw I armoured column during the Spanish Civil War. The tank immediately behind the motorcyclists is a Kleiner Panzerbefehlswagen, a single-gun command car variant. (AirSeaLand/Cody)

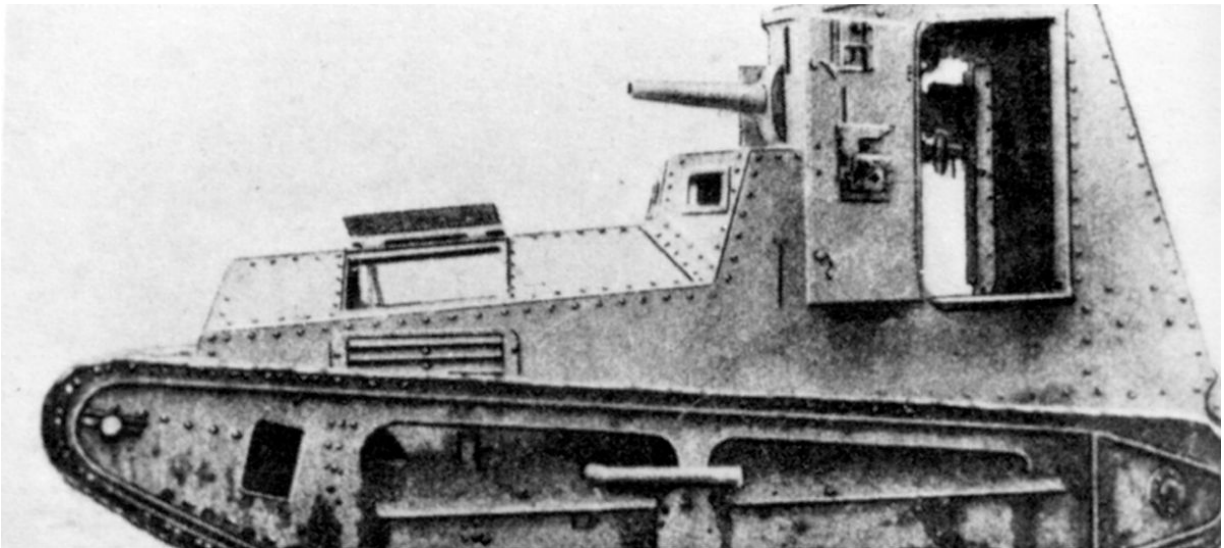
A German Leichter Kampfwagen II, a light tank of World War I. It was armed with a 3.7cm Krupp or 5.7cm Maxim-Nordenfolt gun, and had armour up to 14mm thick.
(AirSeaLand/Cody)

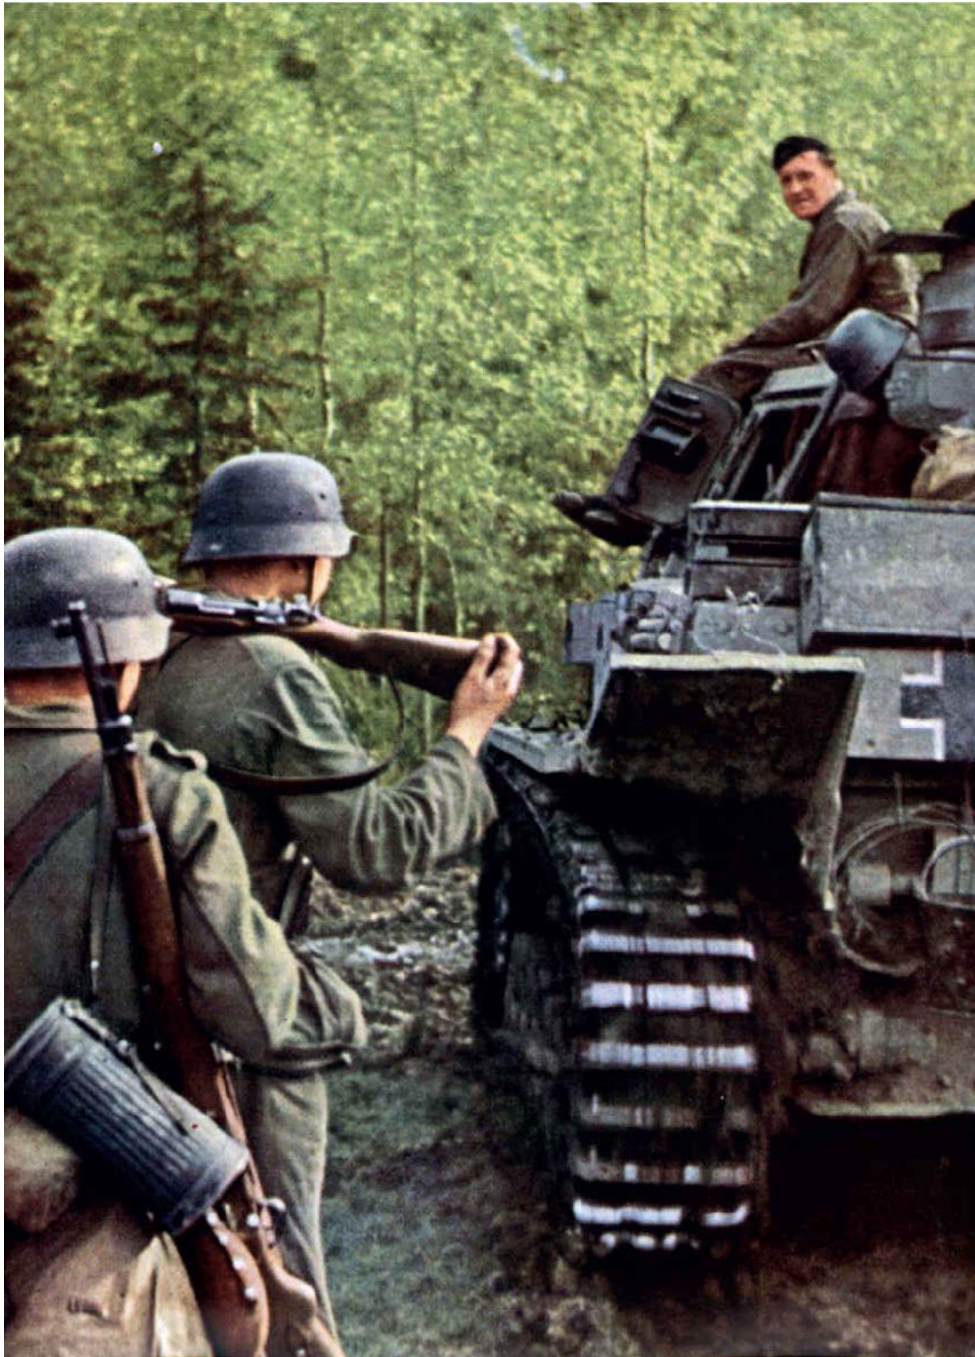
In a relaxed moment, the crew of a PzKpfw IV stop to chat with some passing German infantry. Note how the mudflap is hinged up at the rear, to enable track inspection.
(AirSeaLand/Cody)

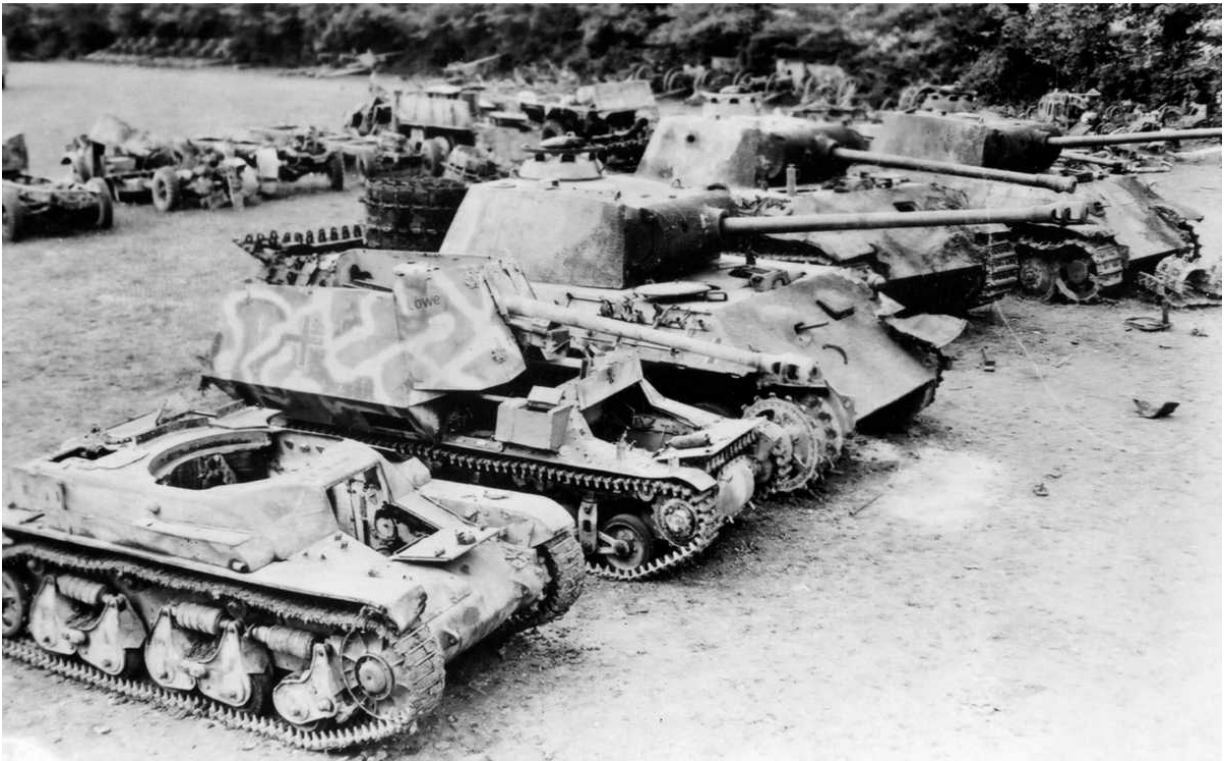
Parked up in France in September 1944, a German formation presents a variety of armoured vehicles, including three PzKpfw V Panthers and, second from the foreground, a 7.5cm PzKpfw 37L Marder I, a conversion of the French Lorraine 37L. The vehicle in the foreground itself is a turretless French R35. (AirSeaLand/Cody)

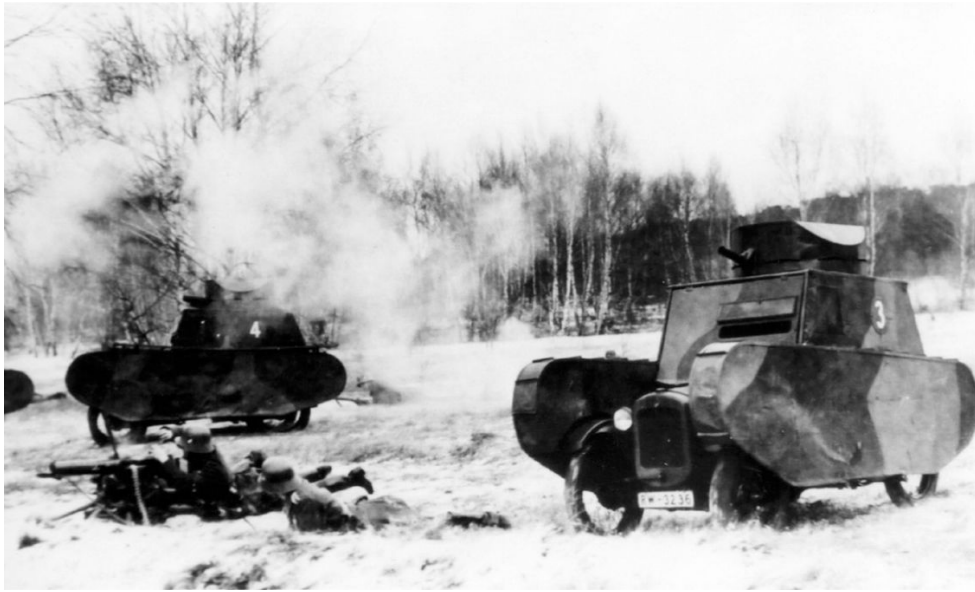
Crude German Panzer training in 1931, the 'tanks' mocked-up by affixing wooden hulls atop standard civilian commercial vehicles. (AirSeaLand/Cody)

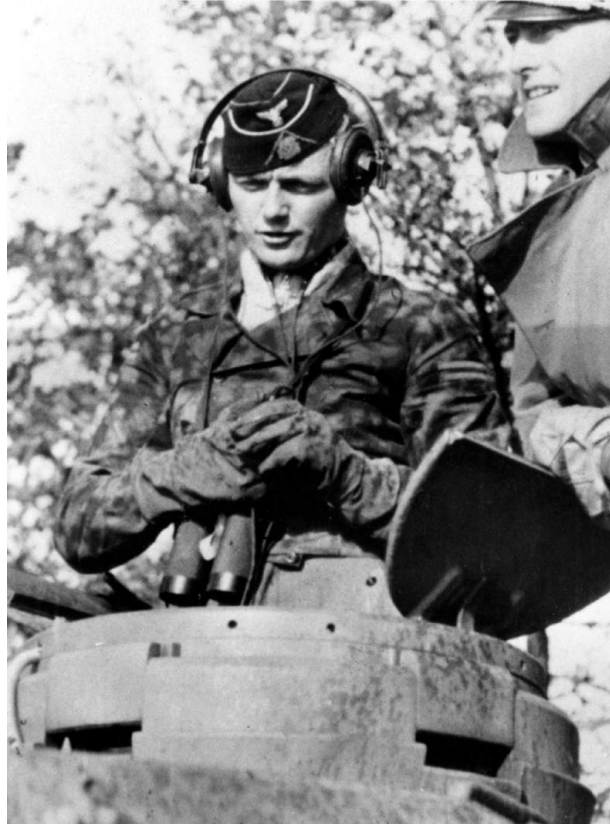
A Waffen-SS tank commander on the Eastern Front in 1943 in his PzKpfw IV, his commander's position featuring the split hatch design rather than the single hatch.
(AirSeaLand/Cody)

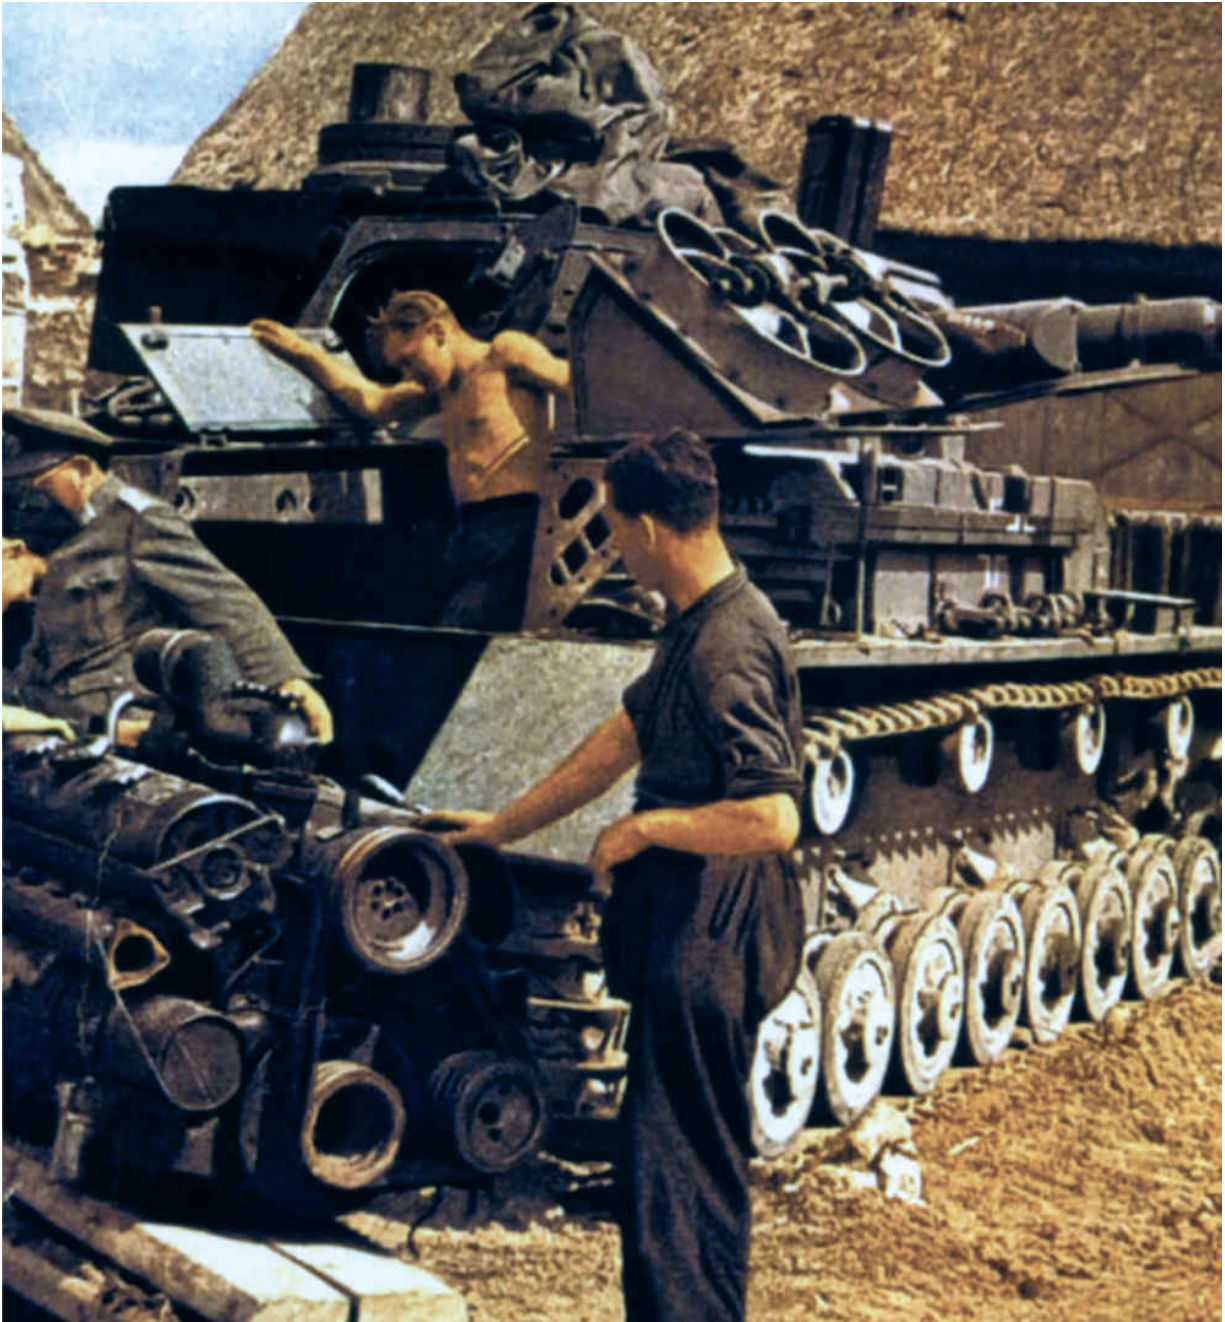
The crew of a PzKpfw IV make a powerplant change, having parked in front of an agricultural building to provide cover during this vulnerable time. (AirSeaLand/Cody)

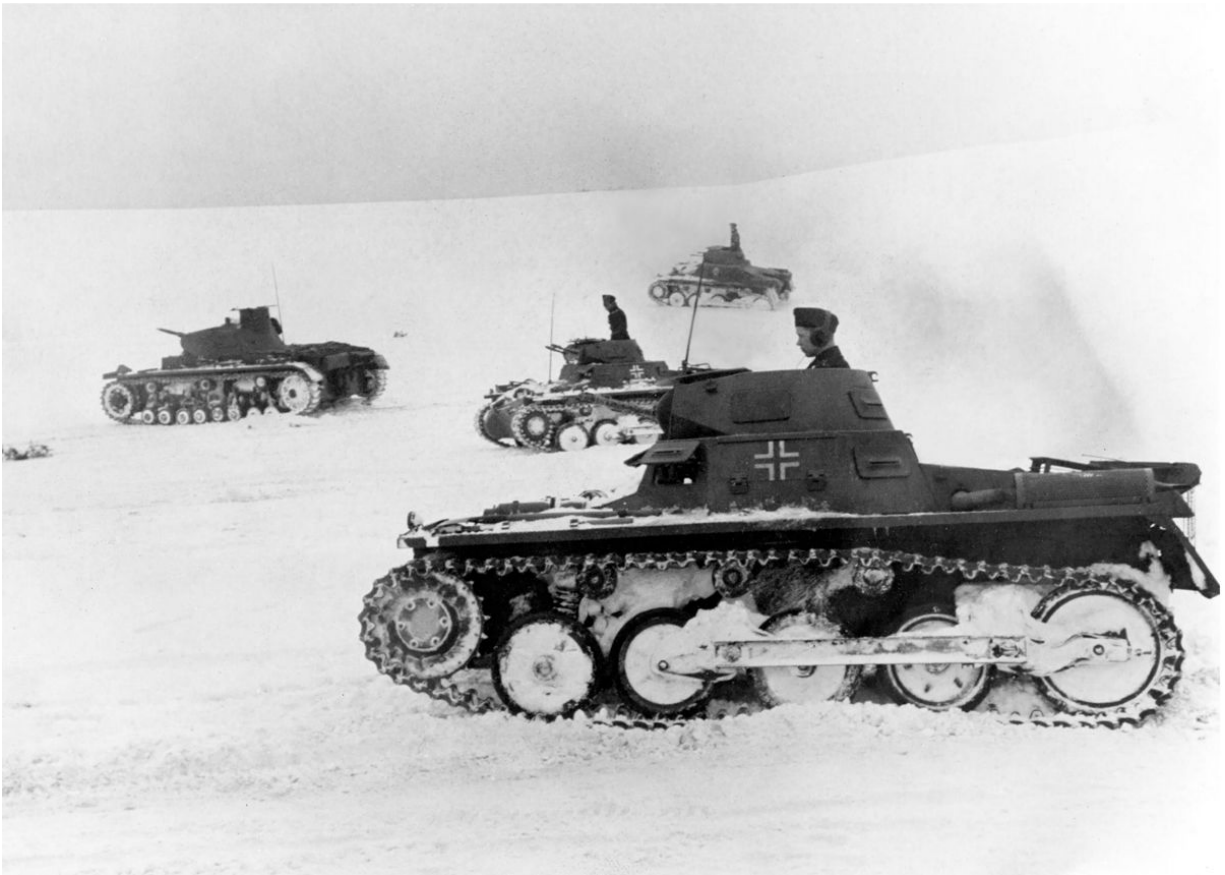
These PzKpfw I Ausf As are serving with the Großdeutschland Division on the Eastern Front in Poland in January 1941. The Ausf A is distinguished from the subsequent Ausf B by the fact that the latter had its rear idler wheel elevated off the ground. (AirSeaLand/Cody)

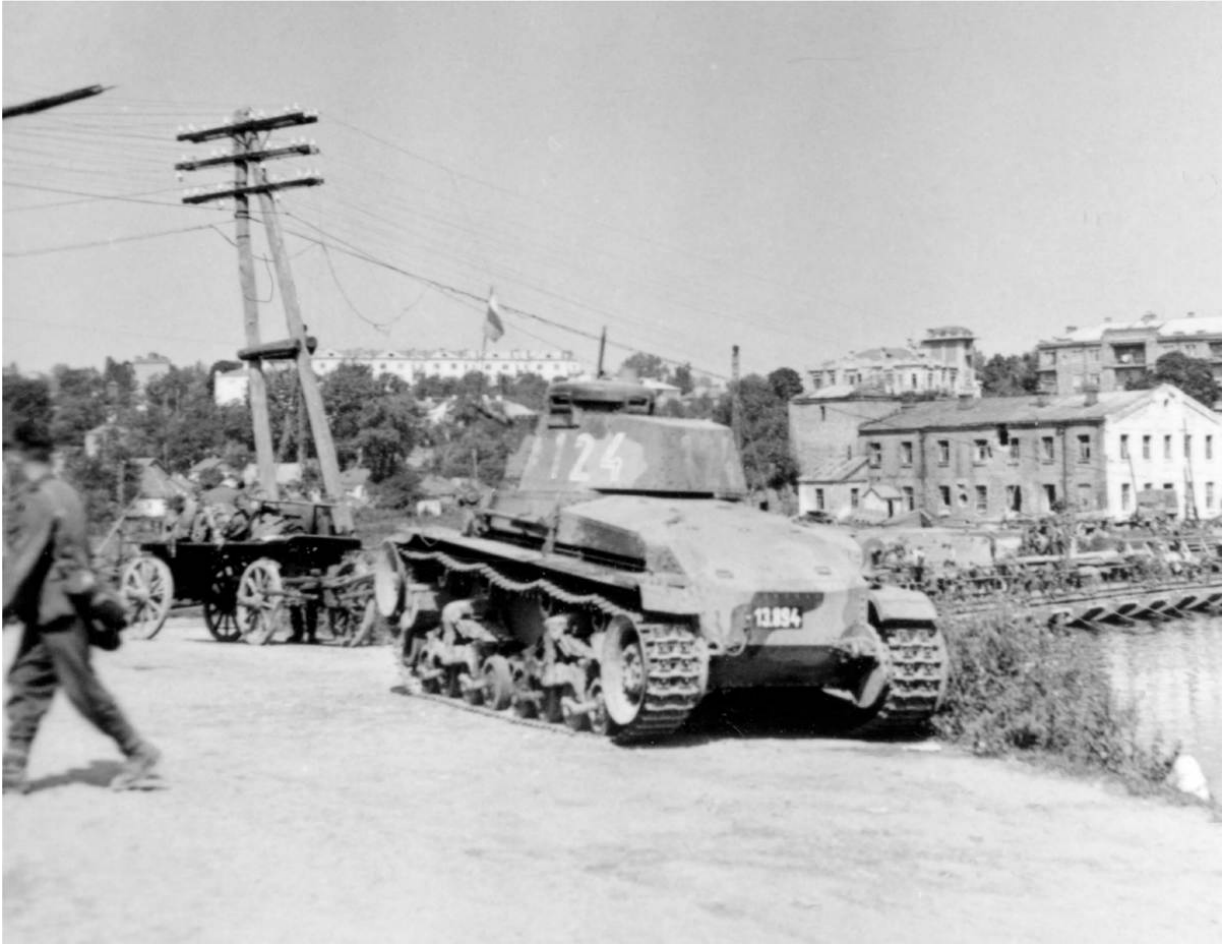
From 1935 to 1937 the Czechoslovakian Army acquired 298 LT vz. 35 tanks based on the Skoda S-II-a design. This tank is better known by its later German designation of PzKpfw 35(t), an example of which is here parked by a sunny harbourside in the early years of the war. (AirSeaLand/Cody)

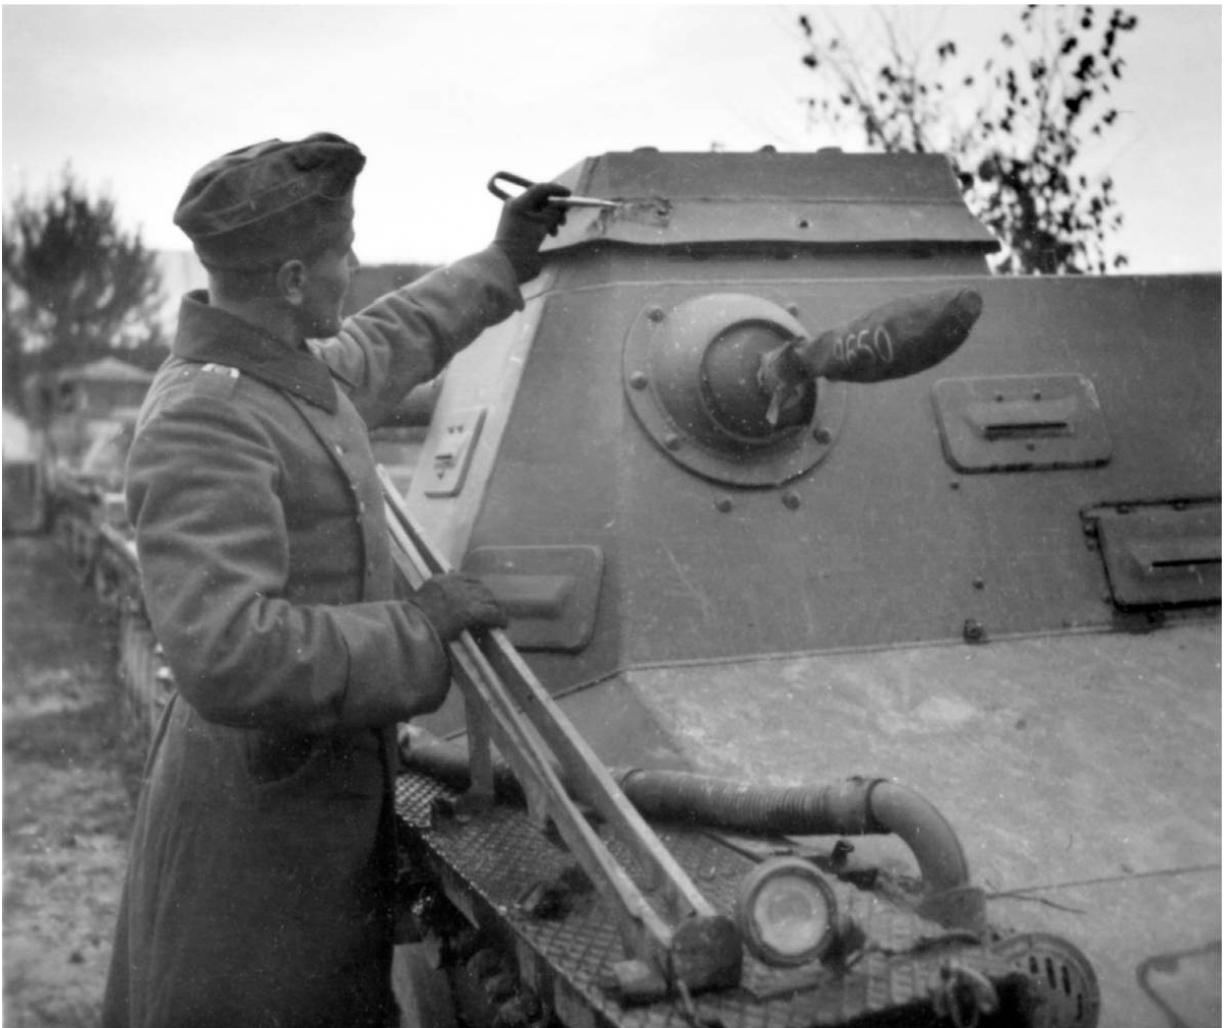
A crewman inspects a bullet strike on his Kleiner Panzerbefehlswagen (SdKfz 265), a variant of the PzKpfw I Ausf A. (AirSeaLand/Cody)

the Ausf A and B chassis. This vehicle was fitted with a fixed superstructure in place of a turret, and was armed with a ball-mounted machine gun for local defence. Two radios were carried, the Fu2 and the Fu6, and the vehicle was manned by a crew of three. About 200 of these conversions were produced by Daimler Benz between 1936 and 1938, emphasizing the fact that from the outset tactical control from well forward was an essential element in the Panzerwaffe's operational technique.

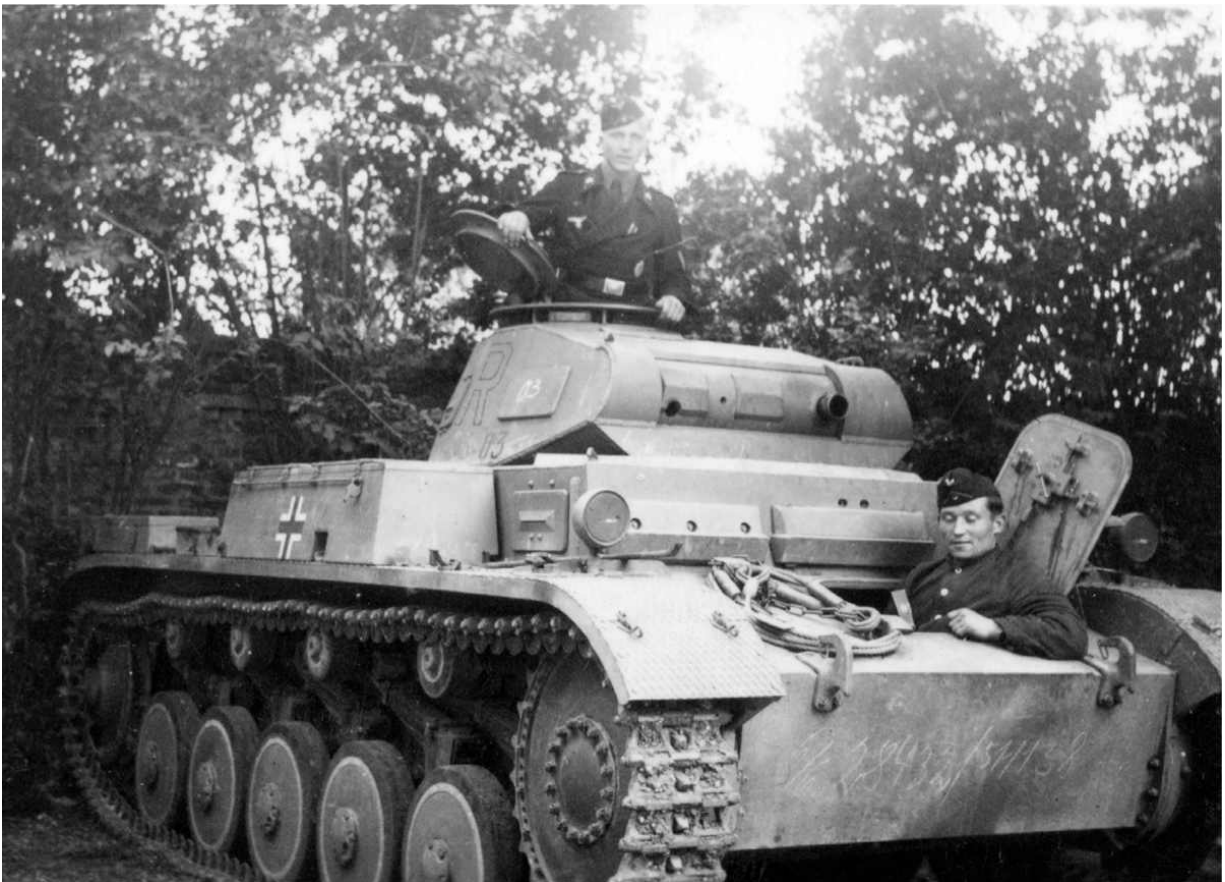
The commander and driver of a PzKpfw II Ausf F pose for a photograph in their hatches. As the PzKpfw II was intended to be an improvement over the PzKpfw I, and was not built for direct action against enemy tanks, all of its armour was essentially ineffective against anything greater than small arms and shrapnel, with the area under the turret front particularly vulnerable. (AirSeaLand/Cody)

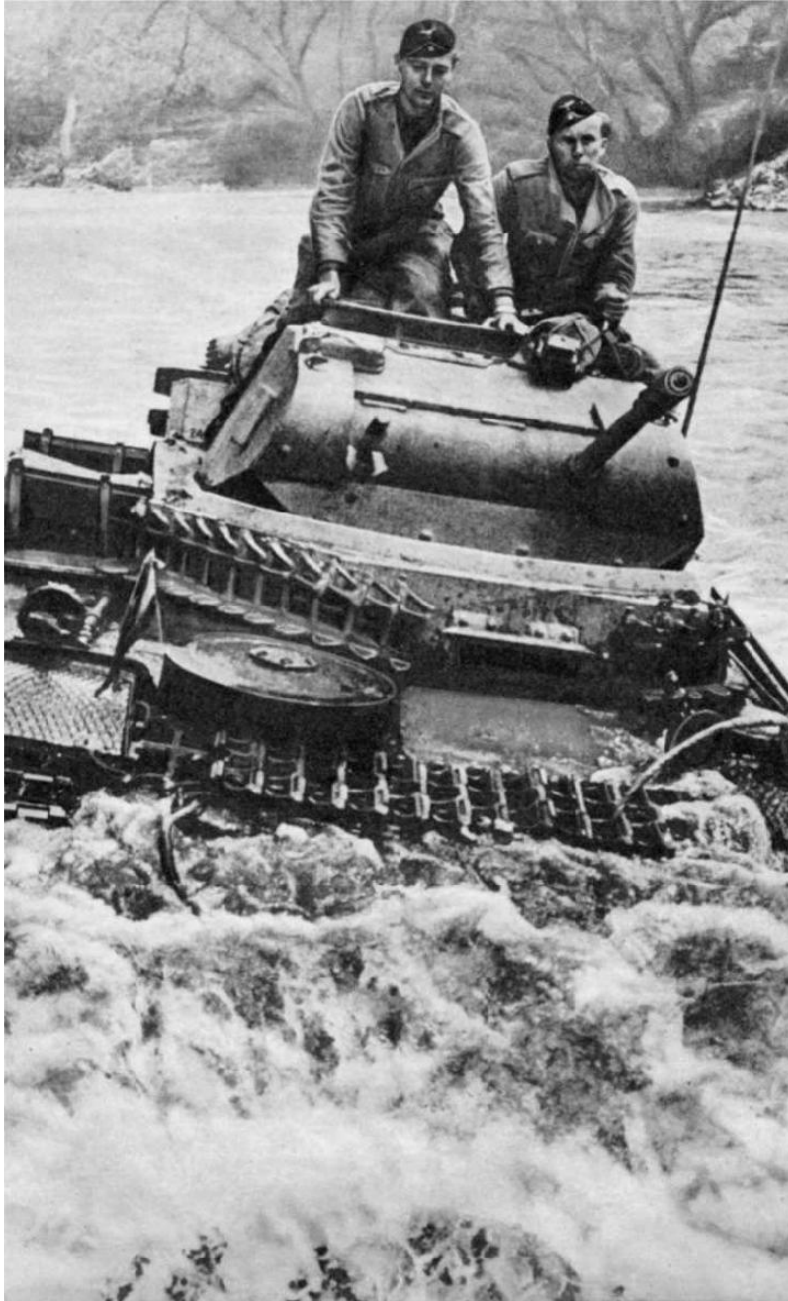
A Panzer II conducts a fording operation. Following the Polish campaign, Ausf D and later versions would incorporate a low turret cupola and additional frontal armour.
(AirSeaLand/Cody)

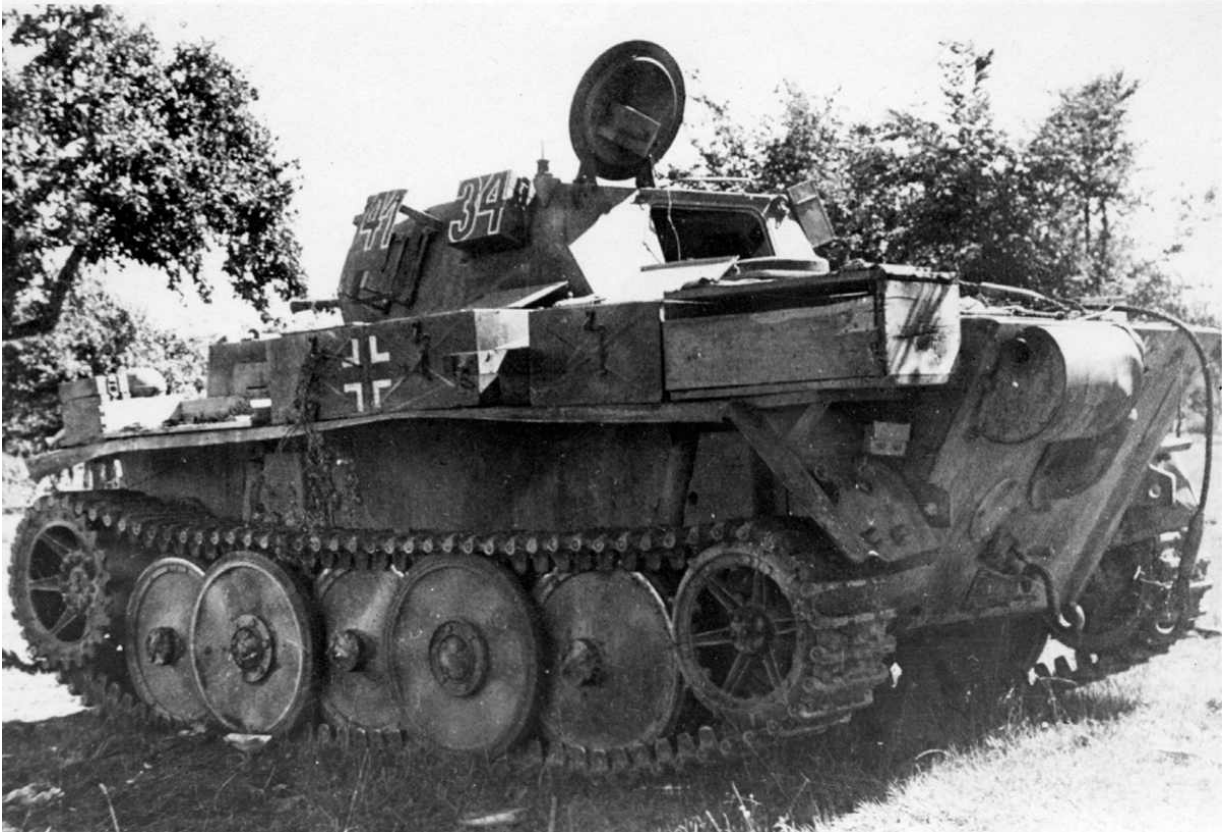
A PzKpfw II Ausf L Luchs (Lynx). As the PzKpfw II's final purpose-built reconnaissance iteration, the Ausf L Luchs had interleaved wheels and proved effective in its intended role.
(AirSeaLand/Cody)

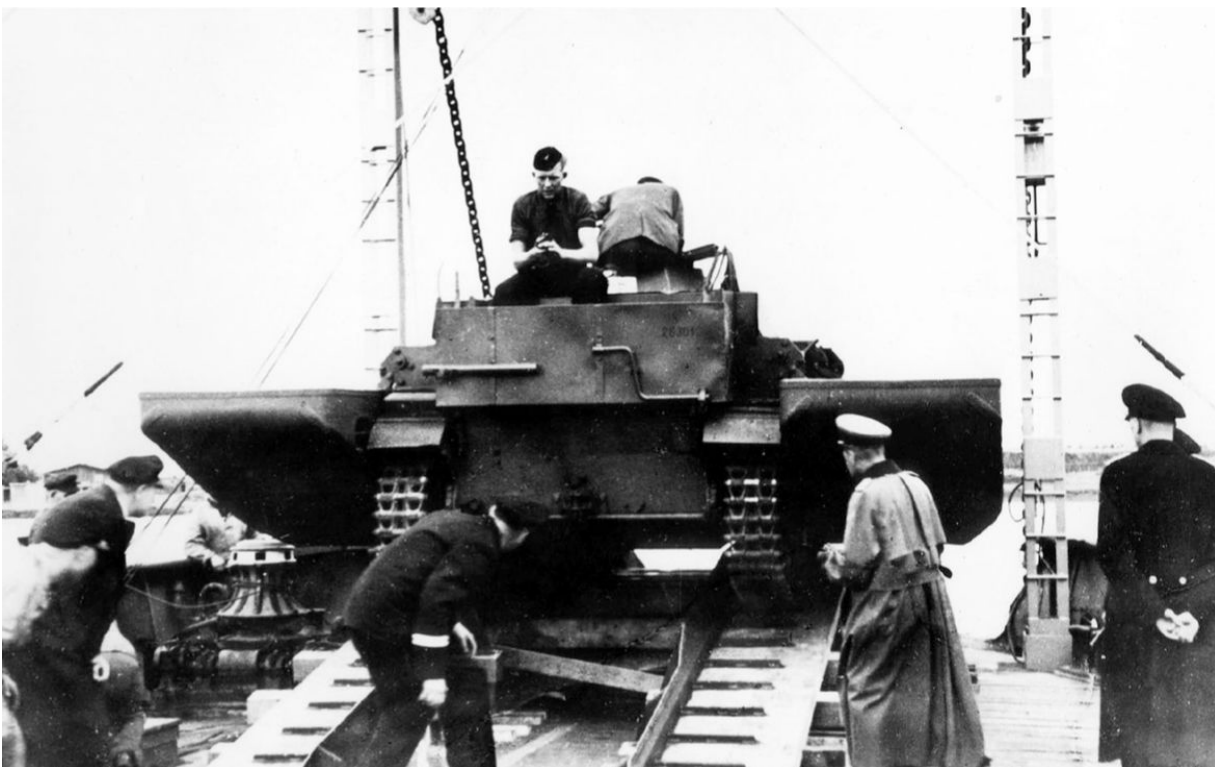
The photograph shows the rather impractical-looking Schwimmpanzer II, the flotation tanks prominently extending out from the sides. These vehicles were mainly utilized for river crossings on the Eastern Front. (AirSeaLand/Cody)

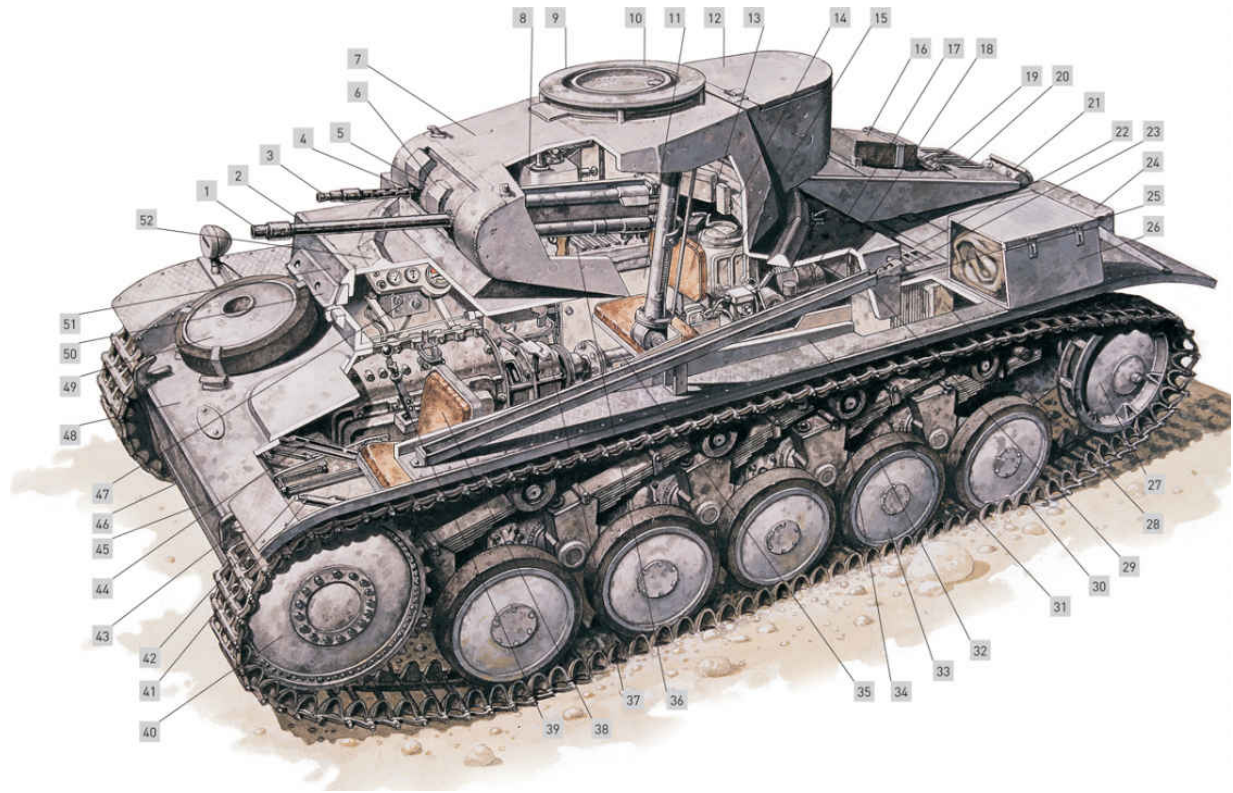
PZKPFW II AUSF F

- 1.** Muzzle flash cowl
- 2.** 2cm KwK 30 L/55 automatic cannon
- 3.** 7.92mm MG 34 co-axial machine gun
- 4.** Direct sight vision port
- 5.** Gun mantlet 30mm internal
- 6.** TZF 4 telescopic gun sight
- 7.** Roof armour 10mm
- 8.** Weapon mount and elevation mechanism
- 9.** Fuel fillers ports in roof to right of turret
- 10.** Commander's cupola/hatch with eight periscopes
- 11.** Armoured fuel tank, 170 litres

- 40.** Drive sprocket
- 41.** ZF gearbox, six forward, one reverse
- 42.** Steering levers
- 43.** Tow cable hooks
- 44.** Steering unit and final drive
- 45.** Sloped front armour, 35 mm
- 46.** Bar for stowing spare track links
- 47.** Instrument panel
- 48.** Glacis plate 20mm
- 49.** Spare wheel
- 50.** Dummy aluminium visor
- 51.** Driver's front armour plate 30mm
- 52.** Bullet splash protector for turret ring

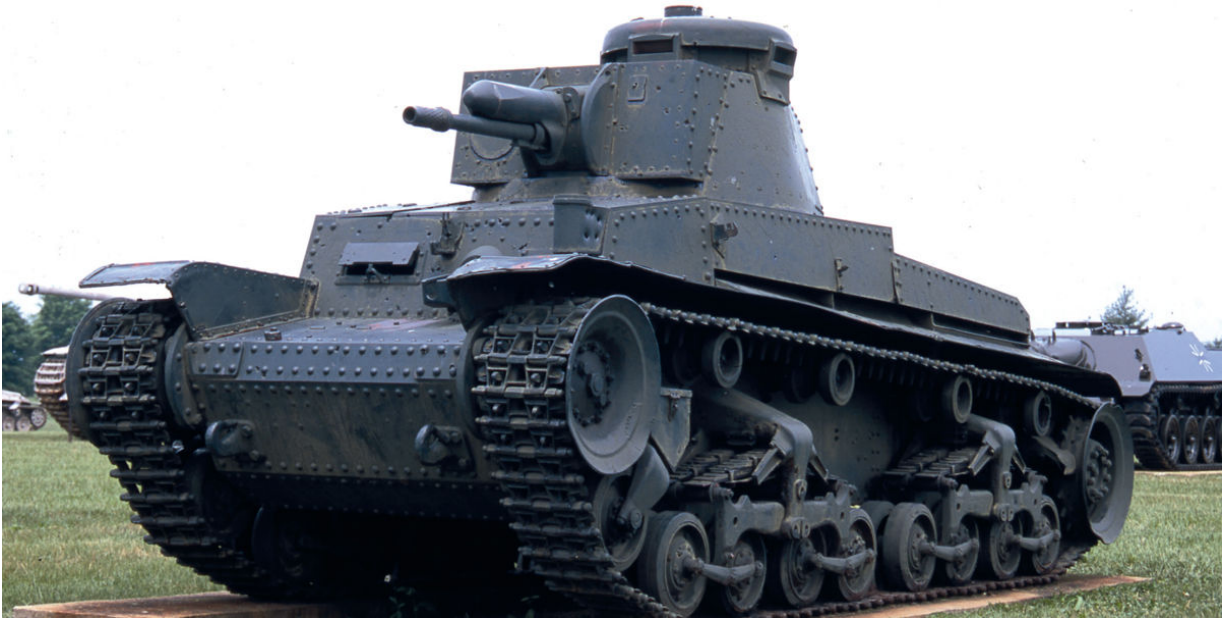
A restored PzKpfw 35(t) on display in the United States. The co-axial 7.92mm machine gun is shrouded with a cover next to the main armament, the 3.7cm gun. (AirSeaLand/Cody)

The vehicle's main armament was an adaptation of the Skoda A3 3.7cm anti-tank gun, fitted with a very simple perforated muzzle brake, and with a semi-automatic falling-block type breech. The recoil cylinder projected some way beyond the mantlet and was protected by a prominent armoured sleeve. The gun fired armour-piercing (AP) shot at a muzzle velocity of 675m/sec and was capable of penetrating 30mm armour at approximately 550m.

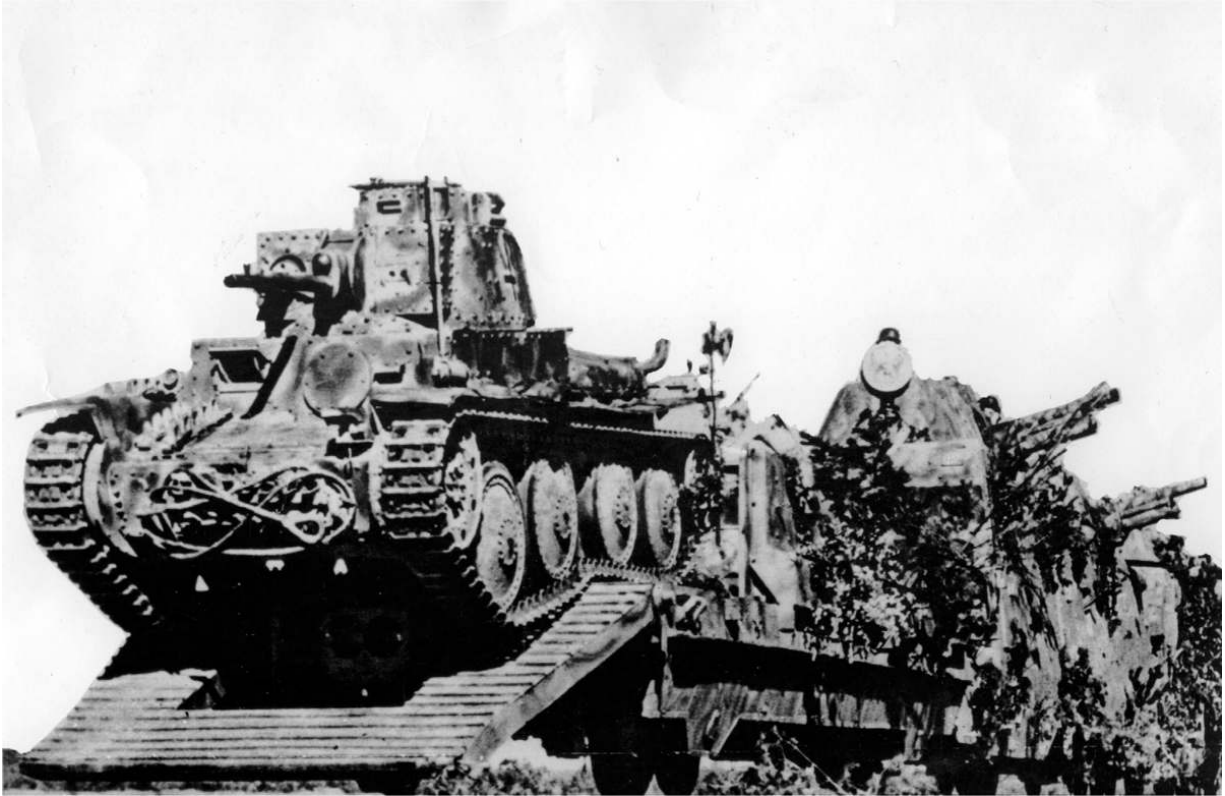
This PzKpfw 38(t) is mounted on the platform of a German Panzerträgerwagen. This specialized rail car had a folding ramp on the front that allowed the tank to disembark and support the train's infantry detachment. The Panzerträgerwagen was lightly armoured to protect the tank's suspension. Armoured trains were allotted two of these, usually at either end of the train. (AirSeaLand/Cody)

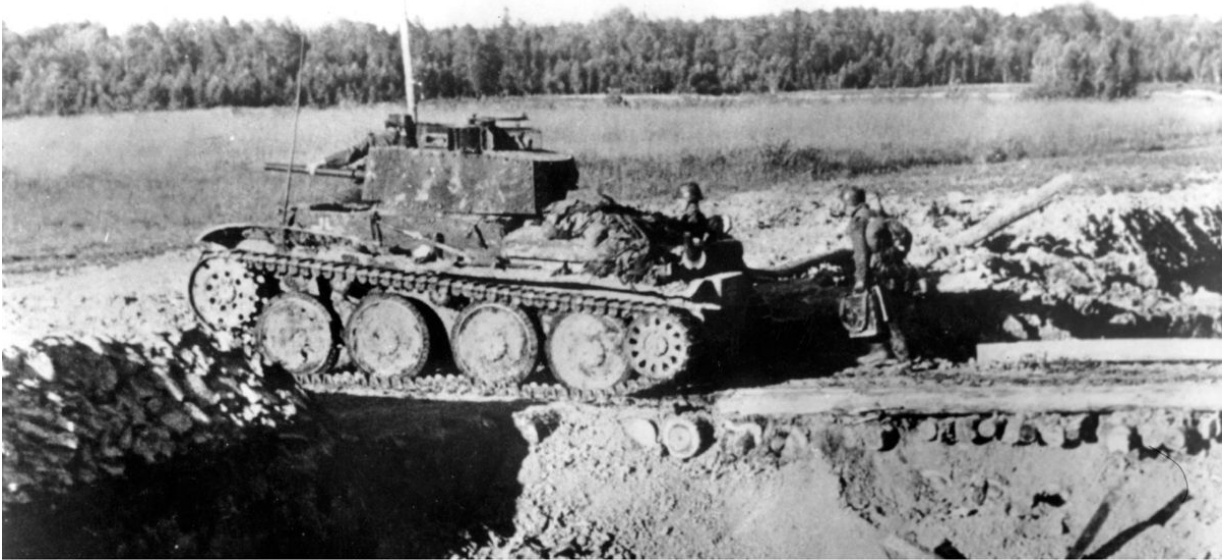
The PzKpfw 38(t) proved well suited to a campaign of rapid movement, but it was not ideal for tank-vs-tank combat. Its 3.7cm gun was poorly suited to fighting against the thickly armoured French tanks. (AirSeaLand/Cody)

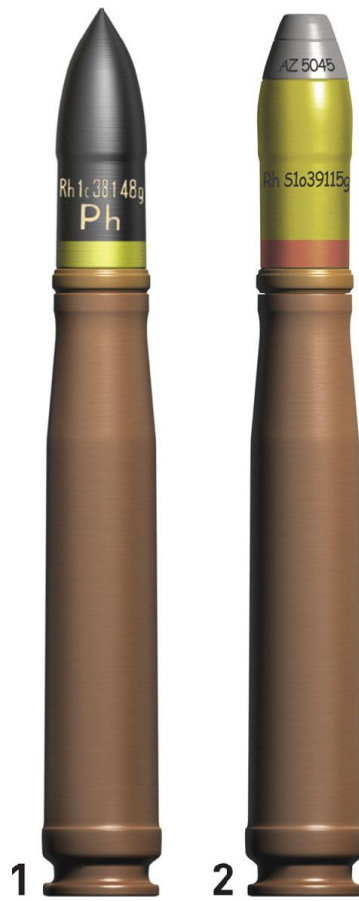
PZKPFW II AMMUNITION

As the most powerful armour-piercing 2cm round available to the Germans, the Swiss Solothurn 20×13.8cm Pzgr 39 138B (1), a belted round, produced a chamber pressure of roughly 3,000atm – the equivalent of 44,000psi – with 46.5kJ muzzle energy. Travelling at 780m/sec, it offered a penetrative capability of 20mm at 100m, 14mm at 500m and 8mm at 1,000m. It was 204mm tall, had a ZZ 1505 fuse and was painted black, with a yellow band to indicate it contained an explosive element. Its markings – here reading ‘Rh.1c38.148g’ – indicated the manufacturer’s code, the shipment code number, the production year and the projectile weight, plus ‘Ph’ (phosphorus). The Sprgr 39 HE round (2) was painted yellow, with a red band. It had an unpainted AZ 5045 nose-detonating steel fuse and 35.9kJ muzzle energy. The labelling here reads ‘Rh.S.1a39.115g’. Both projectiles used the same-sized brass cartridge, with a percussion cap for triggering. The powder was housed in a two-section fabric bag, with a smaller and larger compartment respectively containing an igniter and main propellant charge.

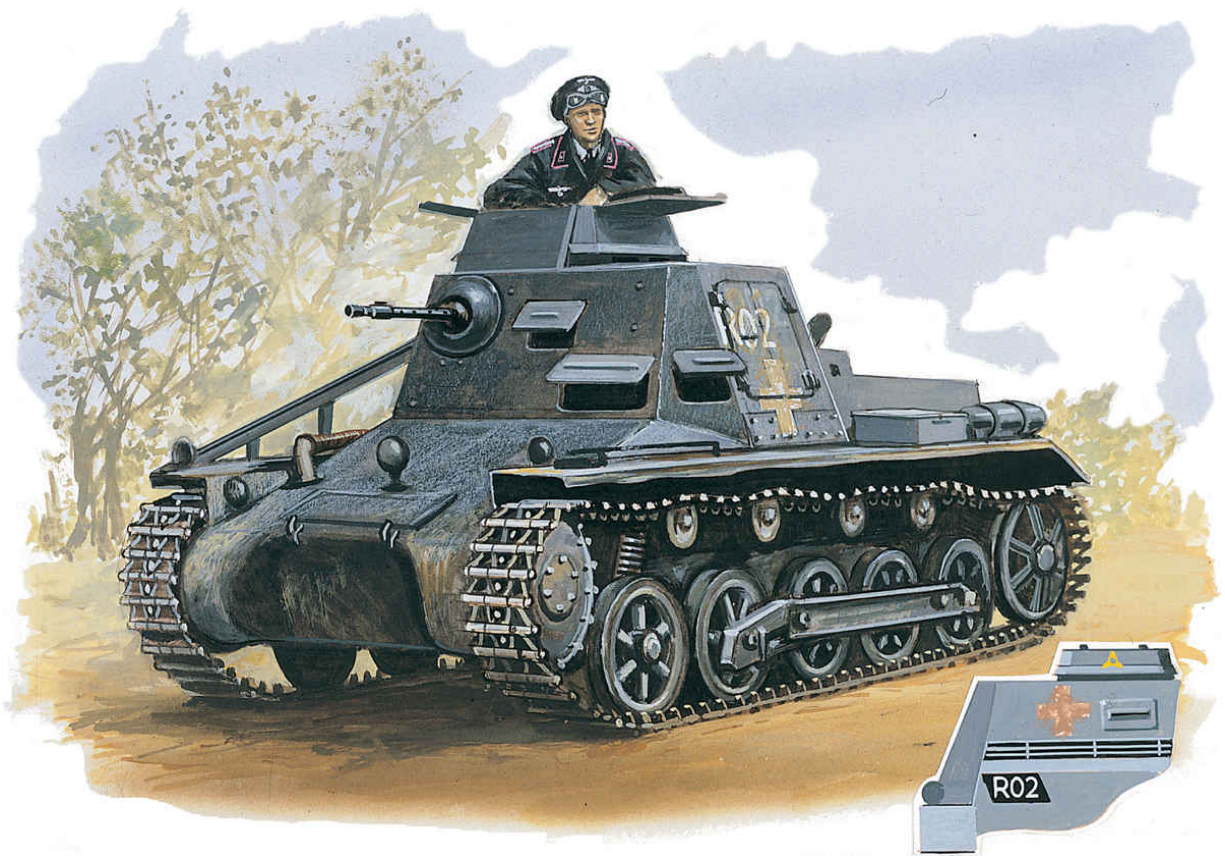
1) Kleiner Panzerbefehlswagen, 4. Panzer-Division; Poland, 1939. A command tank, carrying the usual regimental headquarters tactical numbers on the turret side, and 'R02' on the number plate on the rear hull. The 4. Panzer-Division was one of the few formations to display a divisional insignia in Poland, a three-point star or 'caltrop' shape painted here on the rear of the cupola.

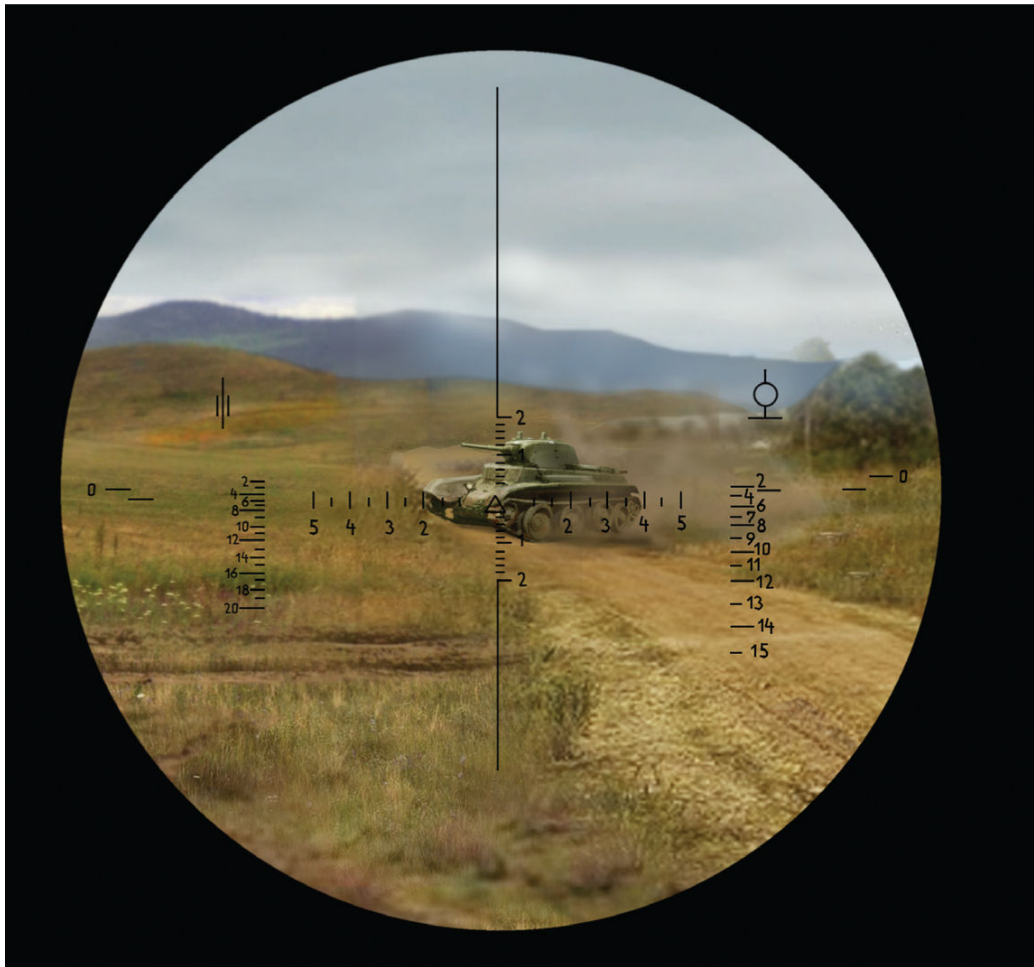
PZKPFW 38(t) SIGHTS

The Zielfernrohr 38(t) telescopic sight had two different reticle patterns. The early Czech pattern (shown here) had the horizontal deflection scale displayed in mils (a measurement denoting 1 yard at 1,000 yards' distance); the later reticle switched to the German pattern of deflection markings by using a series of small triangles. The unit of measure was a graduation (Strich) equalling 1m at 1,000m range, with the large centre triangle having sides of four graduations and the smaller triangle having sides of two graduations. The Czech style of reticles had the range calibrations as a 'staircase' on either side, with armour-piercing on the left and high explosive on the right. The gunner introduced the superelevation
